# SANDY SUCCESS STORIES

New York, New Jersey  
June 2013

Sandy Success Stories is a compilation of case studies on designs, technologies, and natural features that helped a building, site, or neighborhood in the New York and New Jersey region fare relatively well during the storm. The stories highlight pre-existing solutions that, for the most part, did what they were supposed to do and as a result made some part of the region more resilient by minimizing damage or allowing normal operations to resume more quickly.

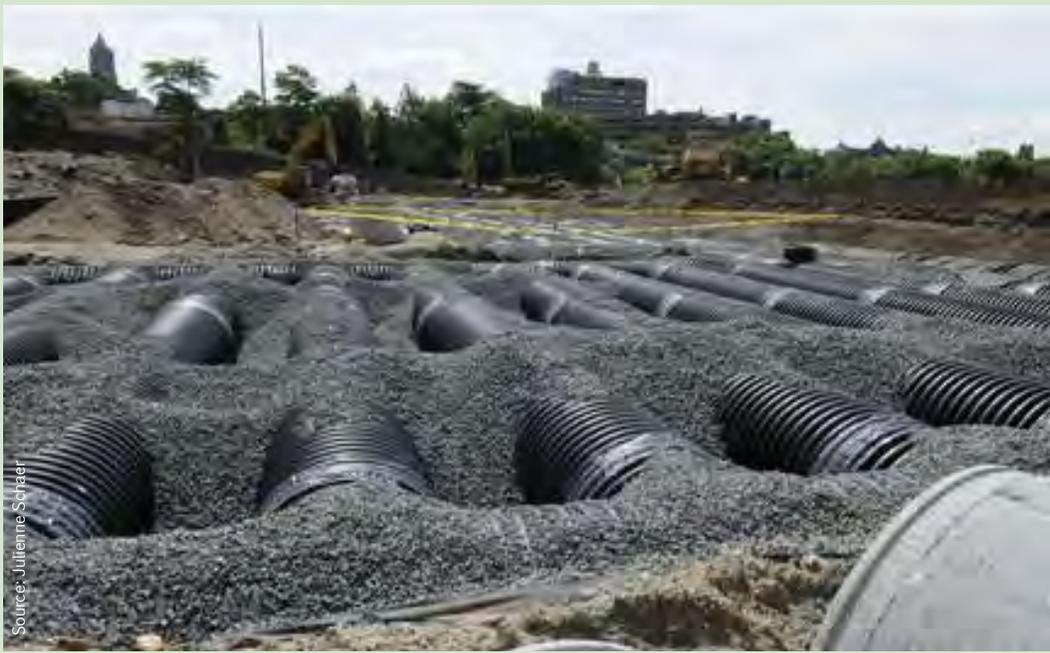
Underground stormwater recirculation tubes at Pier 6

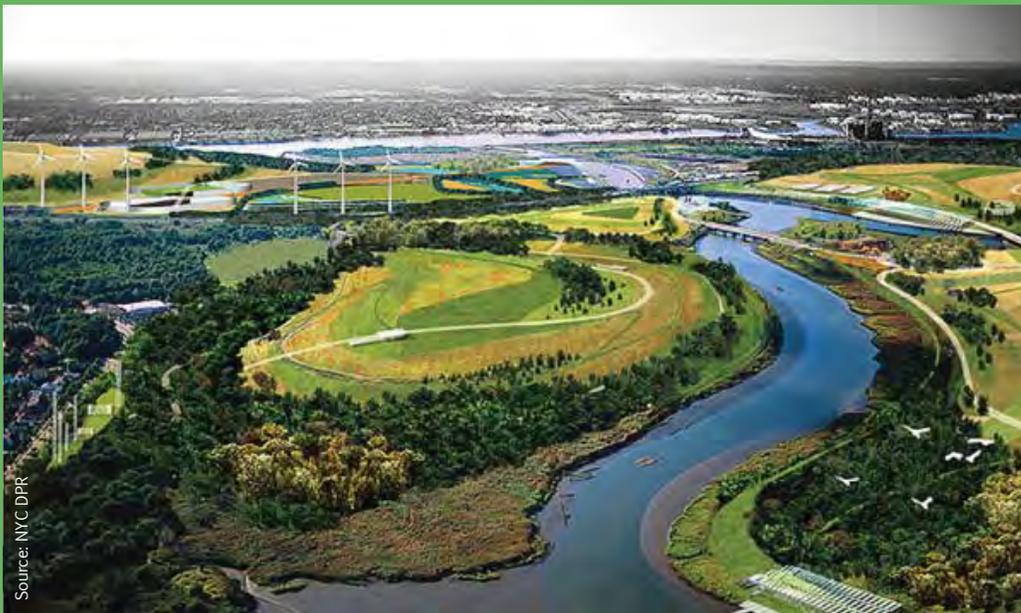
Rendering of Freshkills Park development plan

In the wake of the storm, DPR does plan to update the design of certain park components to further reduce the risk of flooding and damage to proposed buildings on the site. Certain structures will be raised above ground, while others, including park concessions and entry areas, will require fortification to protect against any future floodwaters.

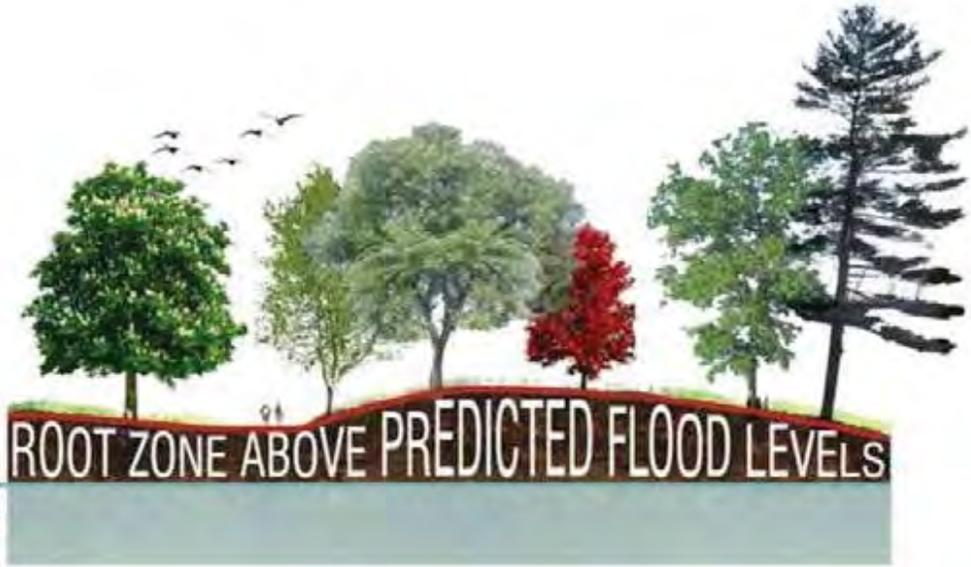
Raised grade level accounts for 2 feet of sea level rise by 2100, allowing for new tree roots to grow above future flood elevation.

To protect the new park and adjacent development zones from flood levels, West 8 proposed the elevation of much of the southern half of the island. To date, construction crews have raised this area by as much as twelve feet above the existing grade and the plan is to add addition-

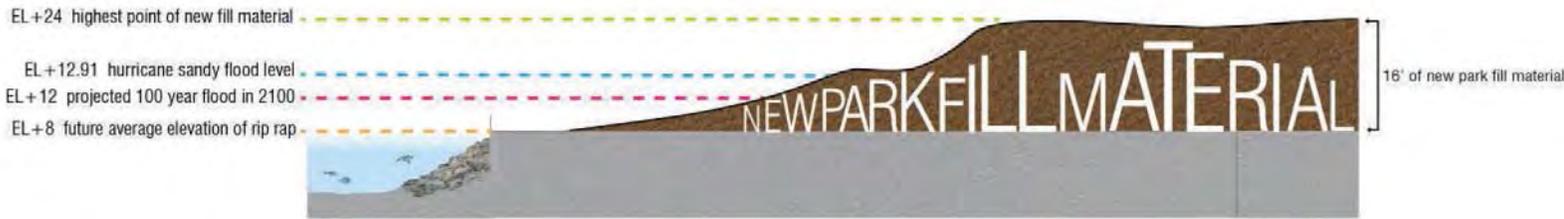
Elevation diagram based upon Sandy Hook datum

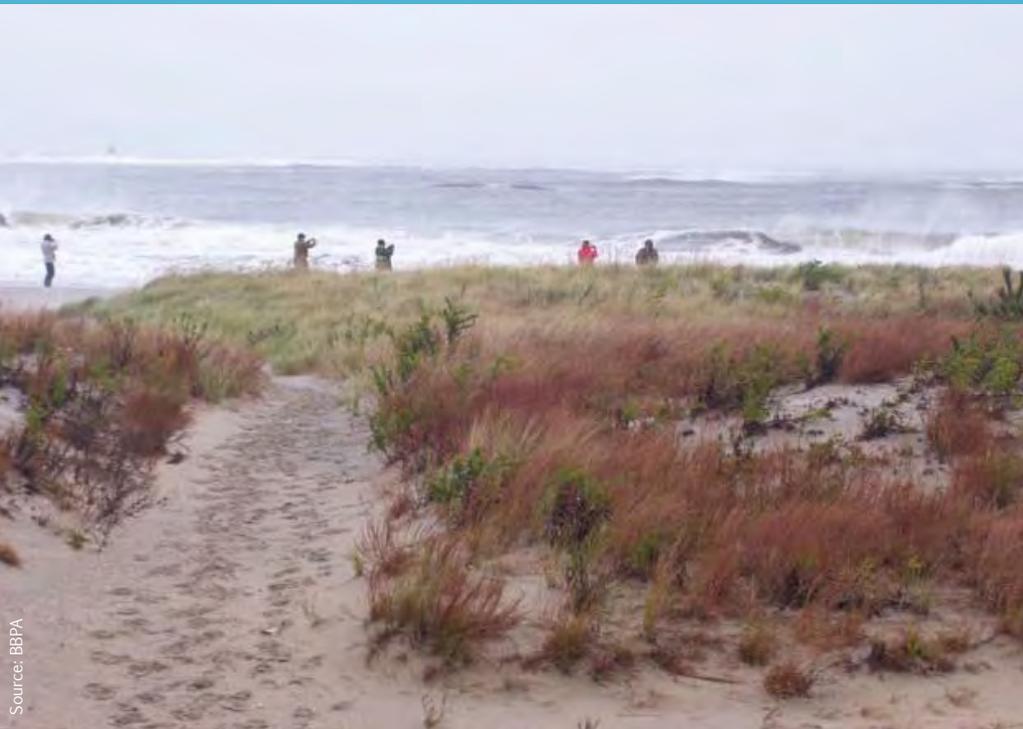
*Beach grass transplanted in the mid-1990s*

With guidance from the New York City Department of Parks & Recreation (DPR) and DEC as well as training from the Green Thumb program, BBPA decided to use its first grant to plant beach grass. BBPA purchased 100 shoots, at a total cost of \$25 in 1992, and gave them to residents, including children, to plant on the dunes adjacent to the neighborhood north of the boardwalk from Beach 24th Street to 26th Street. Within a few months, the fast growing grasses covered the entire dune. The grasses and their roots, which grow fifty feet long in every direction, created a net that captured and held sand, significantly increasing the size of the dune.

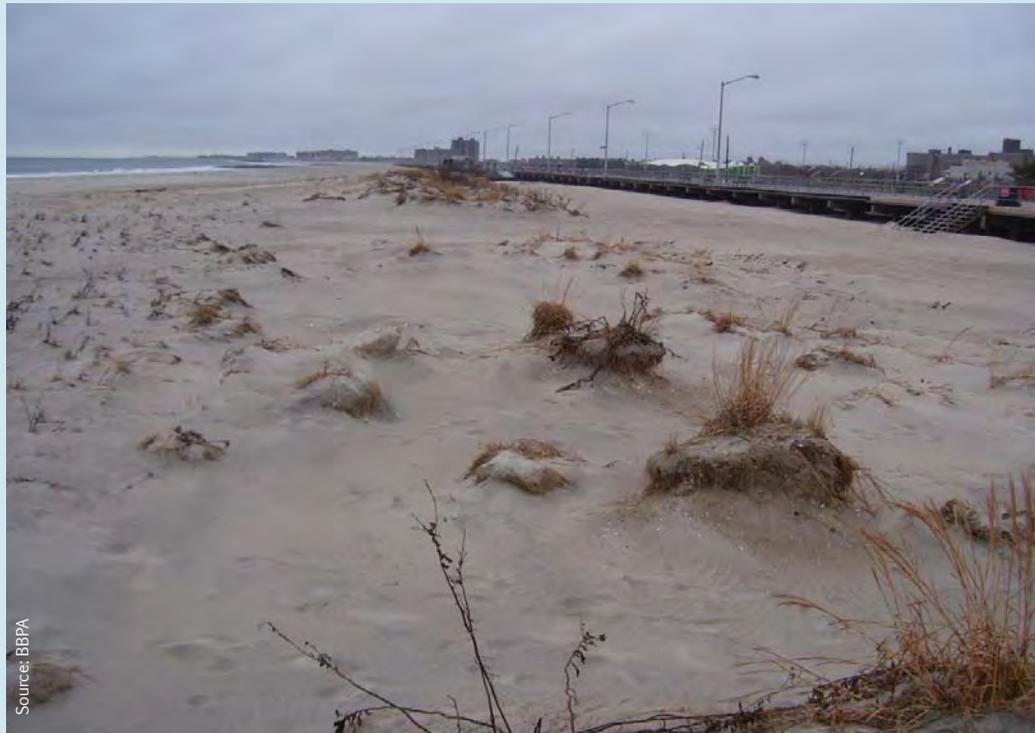
Remaining dunes on Far Rockaway beach post-Sandy

ern dune remained strong and protected the neighborhood from ocean flooding. The shorter northern dune area from Beach 26th to 27th Street, constructed later and planted with trees but no dune grasses breached during the storm surges. As a result, water from one ocean wave passed the lower northern dune and came onto Beach 26th and 27th Streets, causing some minimal flooding. By the time the breach occurred, it was the end of high tide, and the exposure to additional large waves had passed.

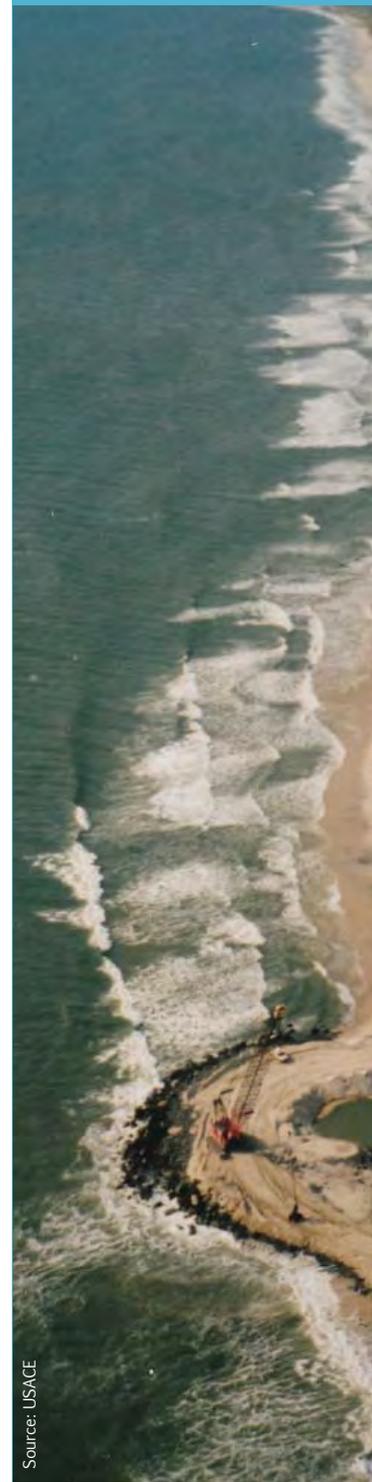
Construction of tapered groin field at Gr

Groin 14A, 1997 beach and new dune shown in background

USACE, under the Fire Island to Montauk Point Reformulation Study, is also planning to shorten the groins to facilitate a decrease in stored sand material within the groin field. By trapping less sand, more of it can drift westward and act as a source of coastal material for the down drift beaches, potentially reducing the need for offshore nourishment. USACE will also continue to pursue more permanent solutions to reduce future storm damage. In the meantime, the organization anticipates the dune growth to continue due to the town's protective regulations, the diverse vegetation, and periodic nourishment. Continued success of the WIP depends upon continued stewardship in protecting the beach and dunes.

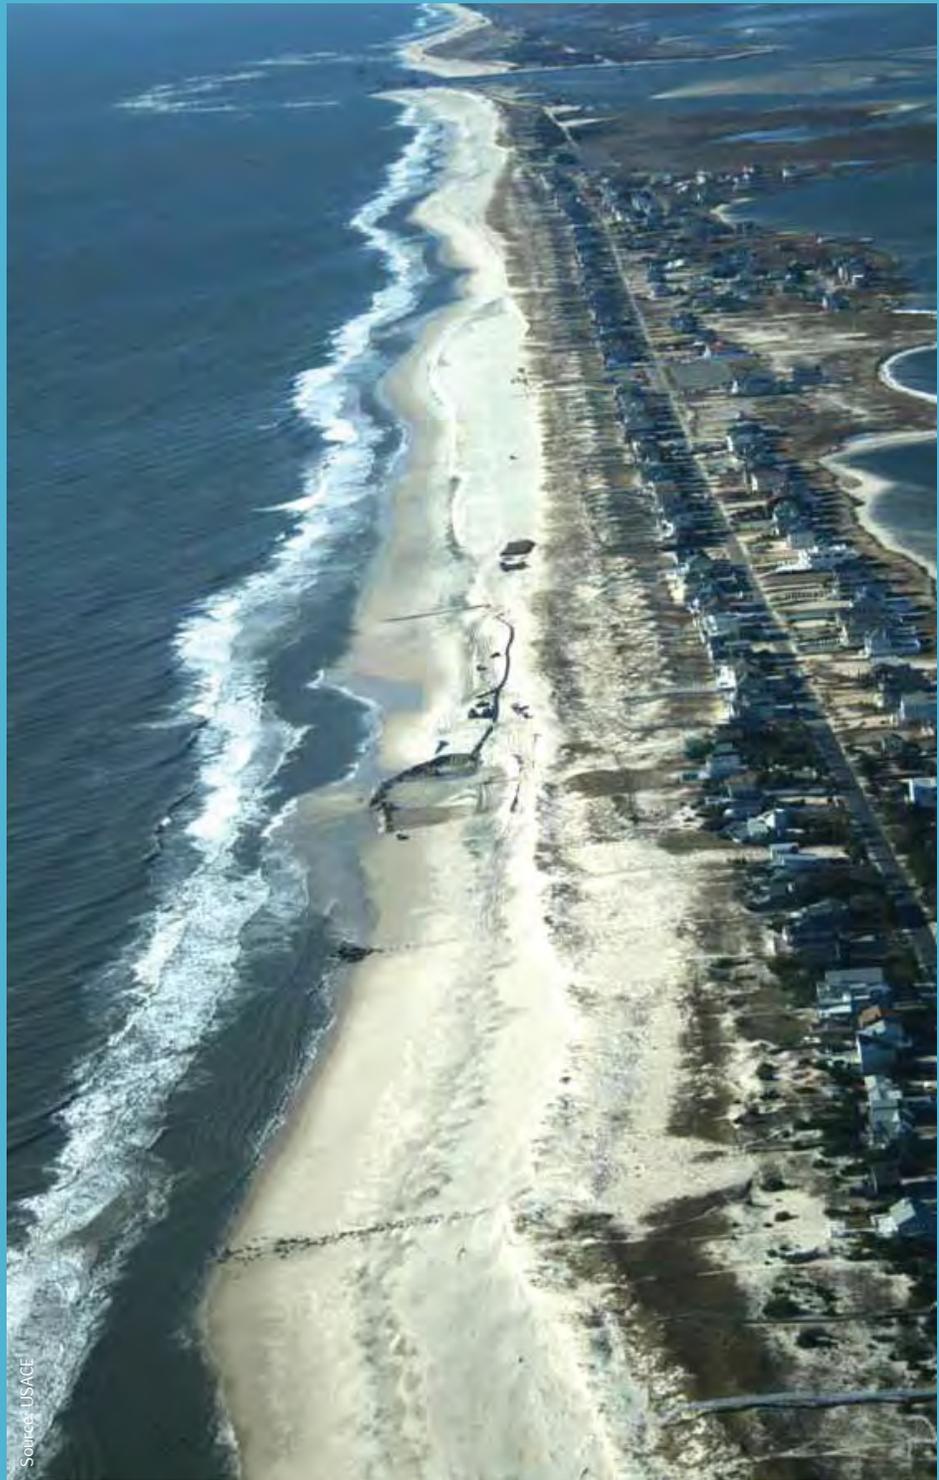
Groin 14 during re-nourishment in 2008 – vegetation in the background on the dune and berm

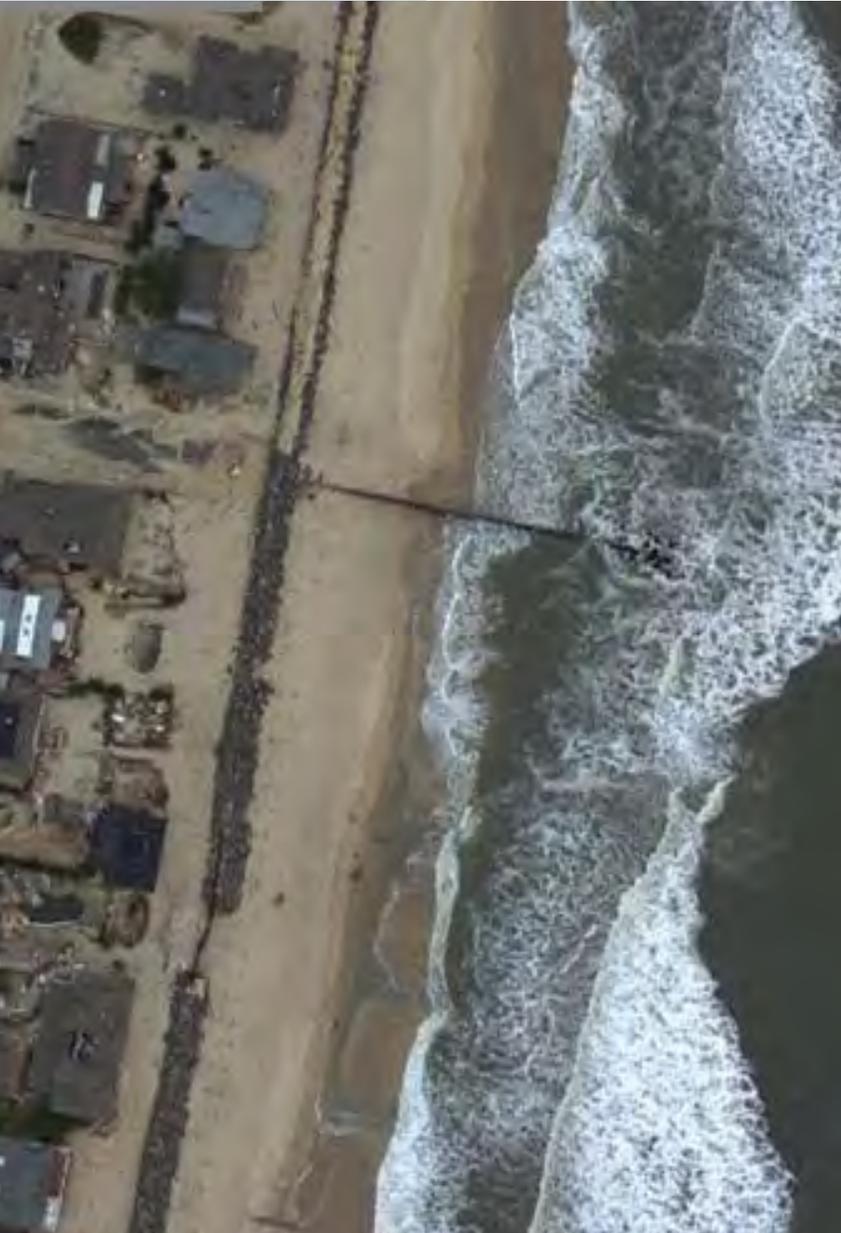
Bay Head Beach, NJ after Sandy

Bay Head was one of the areas hardest hit by Superstorm Sandy. The storm eroded approximately six feet of sand from Bay Head’s beach, exposing the entire seawall and all but two feet of the wooden bulkhead infrastructure. It even revealed pilings from a former boardwalk in some areas. The sand dunes were mostly washed away, except for some sections where property owners had planted and maintained them. Bay Head’s community experienced varying degrees of damage, based not only on the height of the dunes but also on the nature of piling construction, the type of landscaping around the property, and how far the property was set back from the beach.

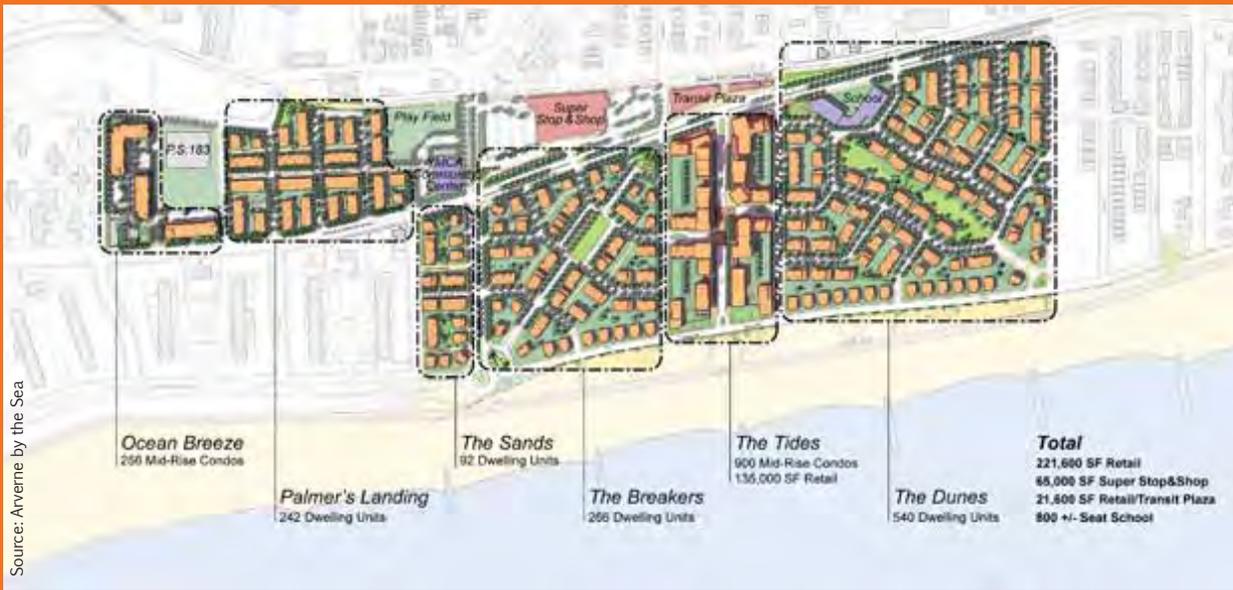
Arverne by the Sea community site plan consisting of six development sites

The development team, with experience of designing new buildings to handle hurricane conditions in Miami, designed the development around multiple levels of protection. The first level of protection is the beach, which is relatively wide in front of Arverne by the Sea. The next level of defense would come from the adjacent wooden boardwalk, which would absorb some of the power of a storm surge. Behind the boardwalk between Beach 73rd and Beach 62nd Streets, the development team constructed a new beachfront preserve that includes sand dunes with grasses holding the dunes in place and a mix of shrubs and trees that can break up the surges that move beyond the boardwalk.

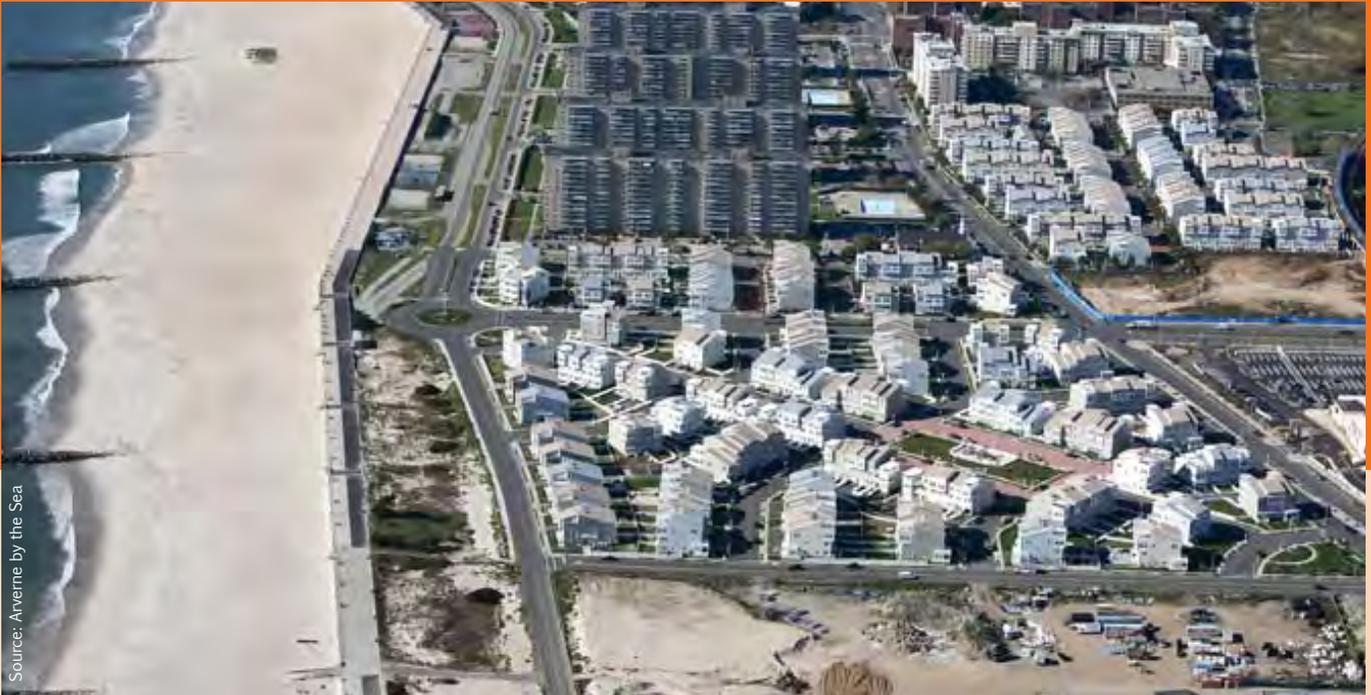
*Aerial view of Arverne by the Sea displaying the multiple levels of protection from the beach to the developments' doorstep*

Arverne by the Sea incorporated a range of protective measures in mitigating storm and flood damage. Incorporation of heightened elevation and advanced storm water management systems proved to be a leading factor in protecting the newer developments of Arverne by the Sea. The developers believe that if they had designed the newer Arverne neighborhoods just six inches lower, the level of damage could have been significant. Additionally, they believe that the varying scales of defense from the water to the property lines played a crucial role in mitigating the surge in this area of the Rockaways.

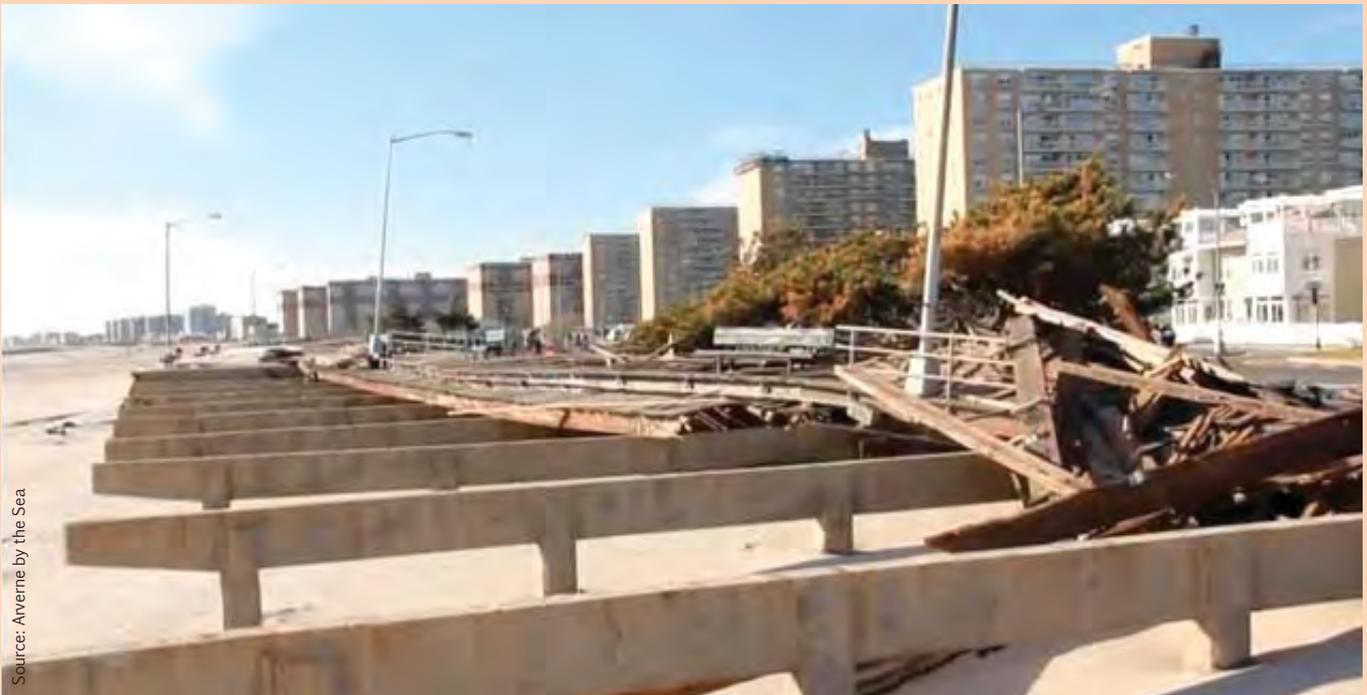
*Destroyed boardwalk near Arverne by the Sea*

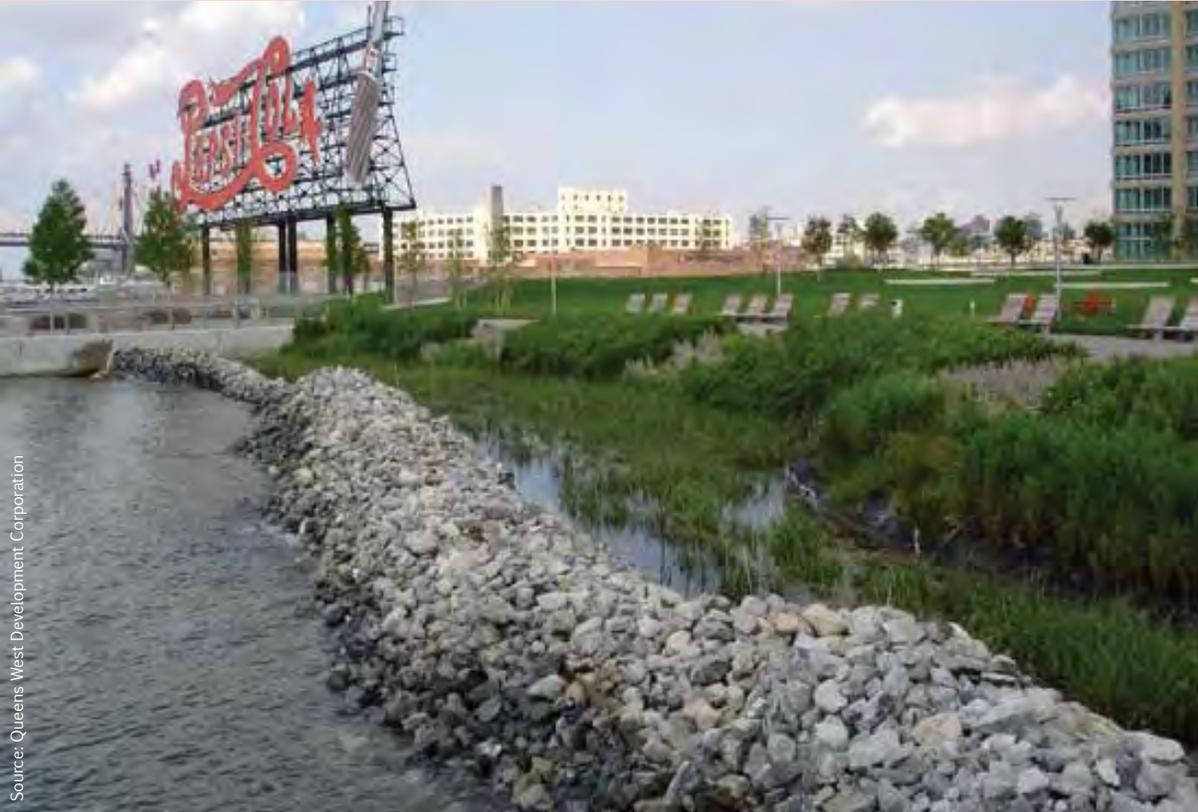
*Rip rap along the water's edge at Gantry Plaza State Park*

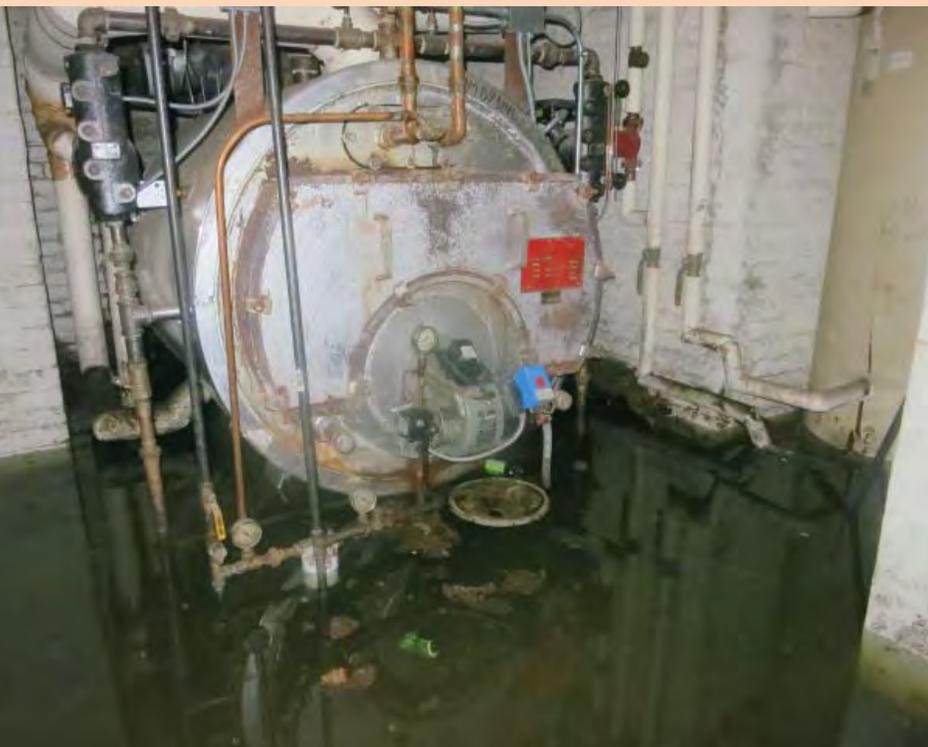
Flooded boiler

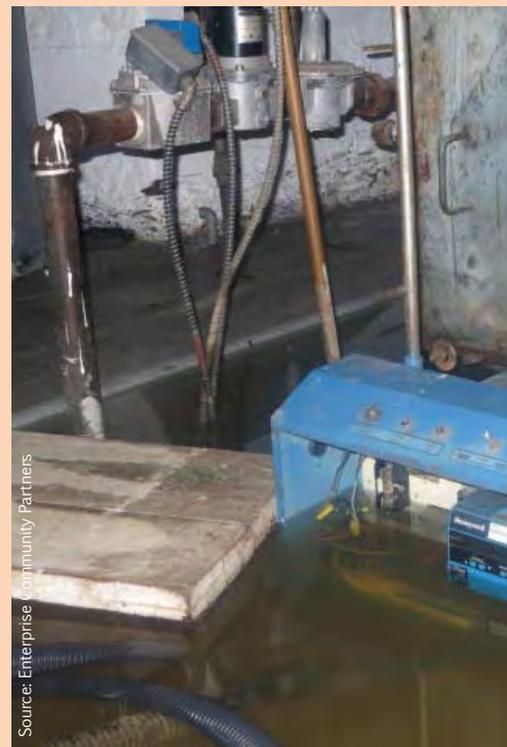
Flooded boiler

HA's newer buildings that had boiler rooms located on the roofs sustained minimal damage. Even with power out in the neighborhood, residents were able to stay warm thanks to the good insulation and air sealing of the buildings. No other building services were affected by the storm.

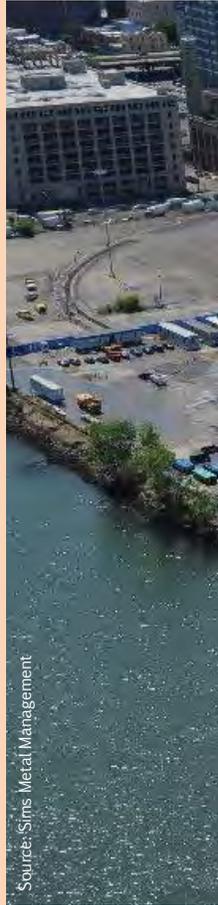
Artificial reefs at west

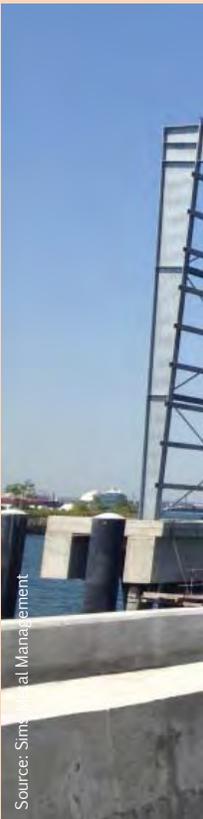
Barge unloading dock

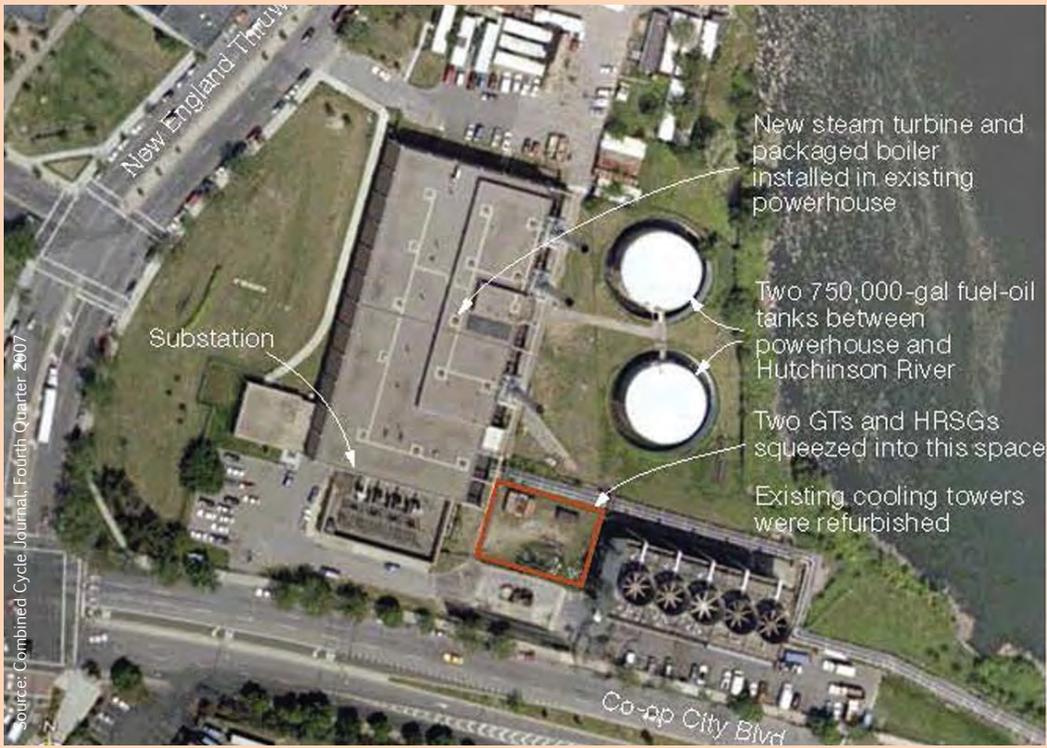
Co-op City's central plant and supporting structure

Capacity:	40 MW
Equipment:	Two dual fuel Siemens SGT-400 Gas Turbines (12.9 MW) Two once through steam generators Dual fuel 150,000 pph auxiliary boiler Steam turbine (15 MW)
Annual Savings:	160,000,000 kWh 8,000,0 Therms \$16 million (payback 4-5 years)
Efficiency:	90% LHV

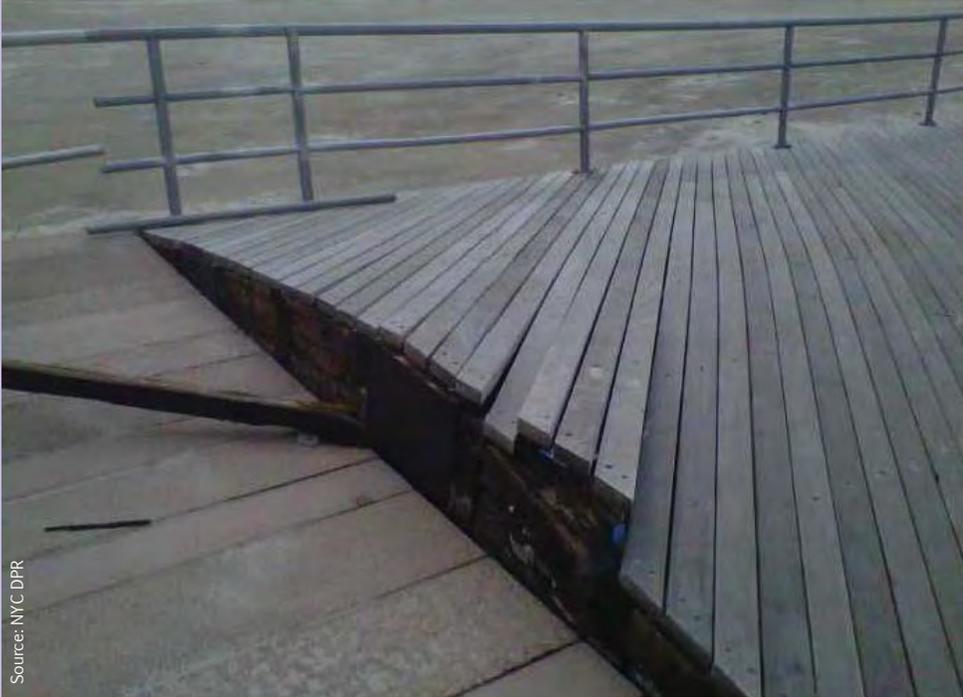
*Destroyed hardwood decking besides pre-stressed concrete planking*

nities or washed them away to sea. The pre-stressed plank installations, however, survived the storm force due their physical weight and strong connections to their supporting structures. In a few locations, there was minor movement of the planks, causing some cracking of connected surrounding materials. In one isolated case, a plank was forced away from its base and deposited on the ground next to the boardwalk. However, almost all the pre-stressed boardwalk survived with minimal damage. DPR expects all the concrete sections to be open to the public by Memorial Day 2013.

DPR has begun repairs to the pre-stressed concrete planks and their supporting infrastructure where necessary. To reduce the future occurrence of cracking, DPR will make some adjustments and improvements in the connections between the planks, as well as connections between the planks and their support structures.

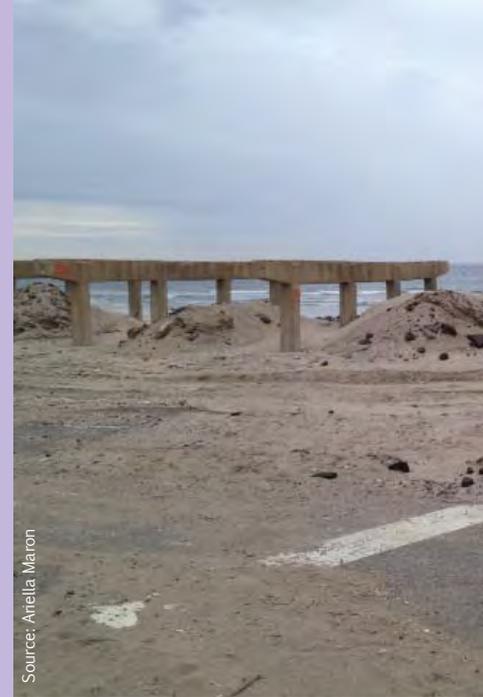
*Destroyed boardwalk after Sandy in the Rockaways, NY*

Superstorm Sandy decimated large portions of the traditional timber boardwalk areas in Coney Island and the Rockaways. The storm surge tore up sections of the boardwalks and in some cases deposited them in the adjacent commu-

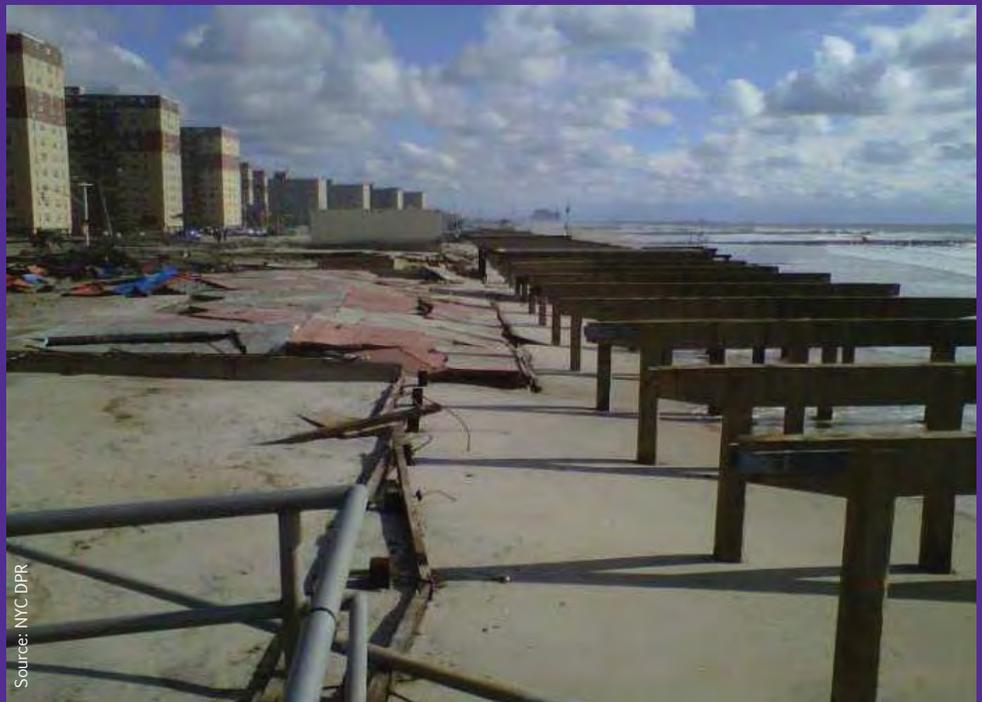
Rockaway Boardwalk, Queens after Sandy: Concrete pile sub-structure without wooden planking system

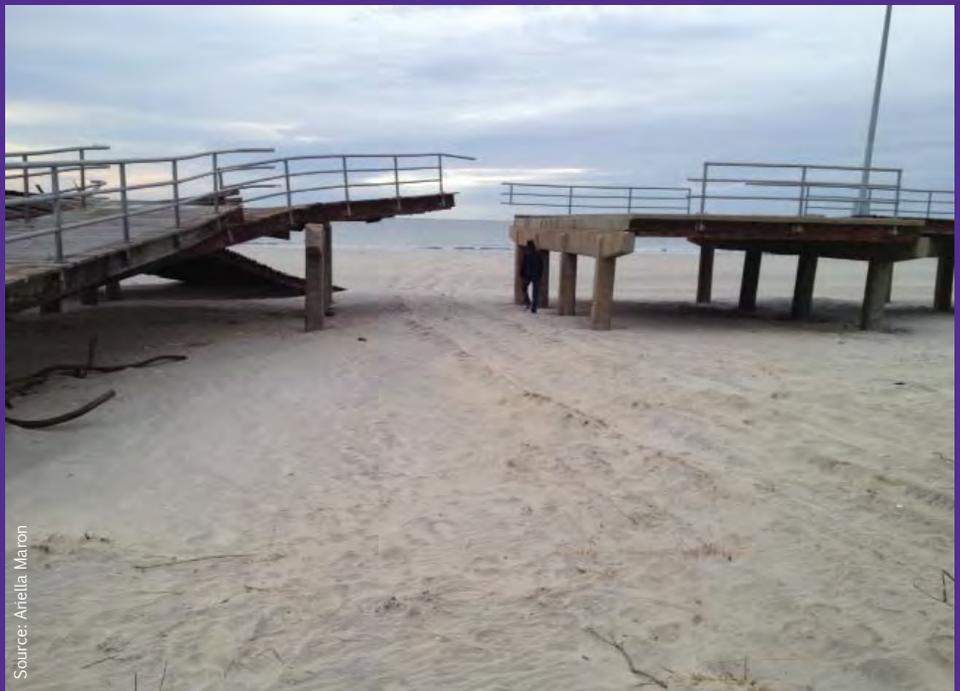
Destroyed boardwalk after Sandy in the Rockaways, Queens
